# Manhole Inspection Summary

Manhole # S67S\_\_013MH

Insp Date: **3/7/08 10:47 AM**

**Location** Address: **6213 Eastbourne Ave.**

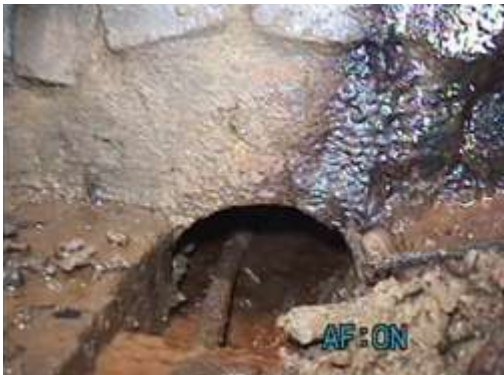
Defect 1

Condition: ☐ Sound ☐ Cracked ☐ Root Intrusion ☐ Loose Brick ☒ **Deteriorated**

Infiltration: ☐ None ☐ Joint ☐ Cracks ☐ Mortar ☐ Roots ☒ **Wall**

Mineral deposits on barrel wall

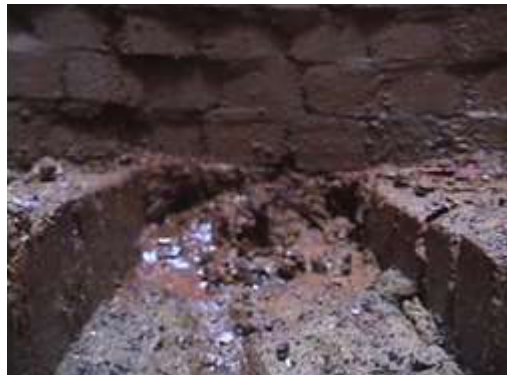
Defect 3

Comments **HEAVY DEBRIS IN CHANNEL.**

Condition: ☐ Sound ☐ Cracked ☐ Root Intrusion ☐ Deteriorated ☐ Leaks ☒ **Debris**

Heavy debris in incoming 6 o'clock

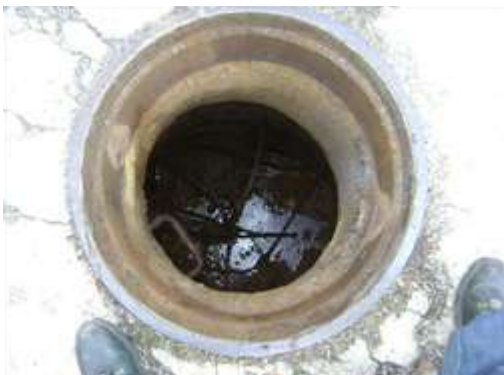
Defect 2

**Frame** Offset: **1** (in.) Condition: ☒ Sound ☐ Cracked ☐ Leaks

Frame offset defect

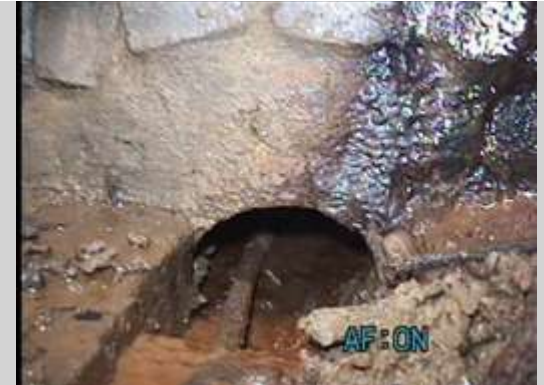
12 O'Clock Outflow

8 in. Circular Gravity Sewer  
Pipe Out @ 12 O'Clock

Pipe Height: **8.4** (in.) Rod and Bar (Angled)  
Pipe Material: **Clay** ☐ Pipe Lined  
Invert Depth: **8.50** (ft.) Flow Characteristics: **None**  
Deposits: ☐ None ☐ Mud ☐ Sludge ☒ **Debris** ☐ Grease  
Silt Depth: **2** (in.) Deposits Extent: **Medium**  
Infiltration: **None** Pipe Seal Cond: **Sound**

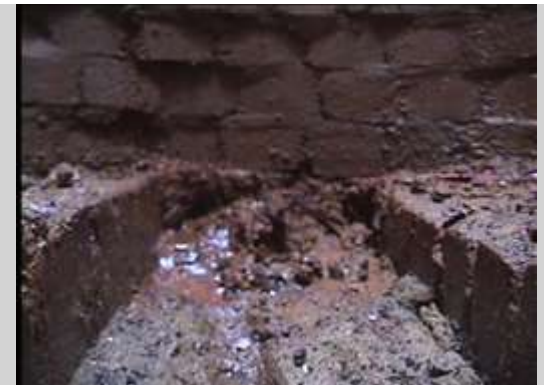
6 O'Clock Inflow

8 in. Circular Gravity Sewer  
Pipe In @ 6 O'Clock

Pipe Height: **8.4** (in.) Rod and Bar (Angled)  
Pipe Material: **Clay** ☐ Pipe Lined  
Invert Depth: **8.46** (ft.) Flow Characteristics: **Slow**  
Deposits: ☐ None ☐ Mud ☐ Sludge ☒ **Debris** ☐ Grease  
Silt Depth: **7** (in.) Deposits Extent: **Heavy**  
Infiltration: **None** Pipe Seal Cond: **Unknown**
